00Y-TR- 63-20

JUNE 1963

## AIRMUNITIONS TEST REPORT

SERVICE AND SHELF LIFE OF  
EXPLOSIVE SWITCH P/N 1186 FOR  
T3019E5 ARMING PROGRAMMER  
IM99A MISSILE

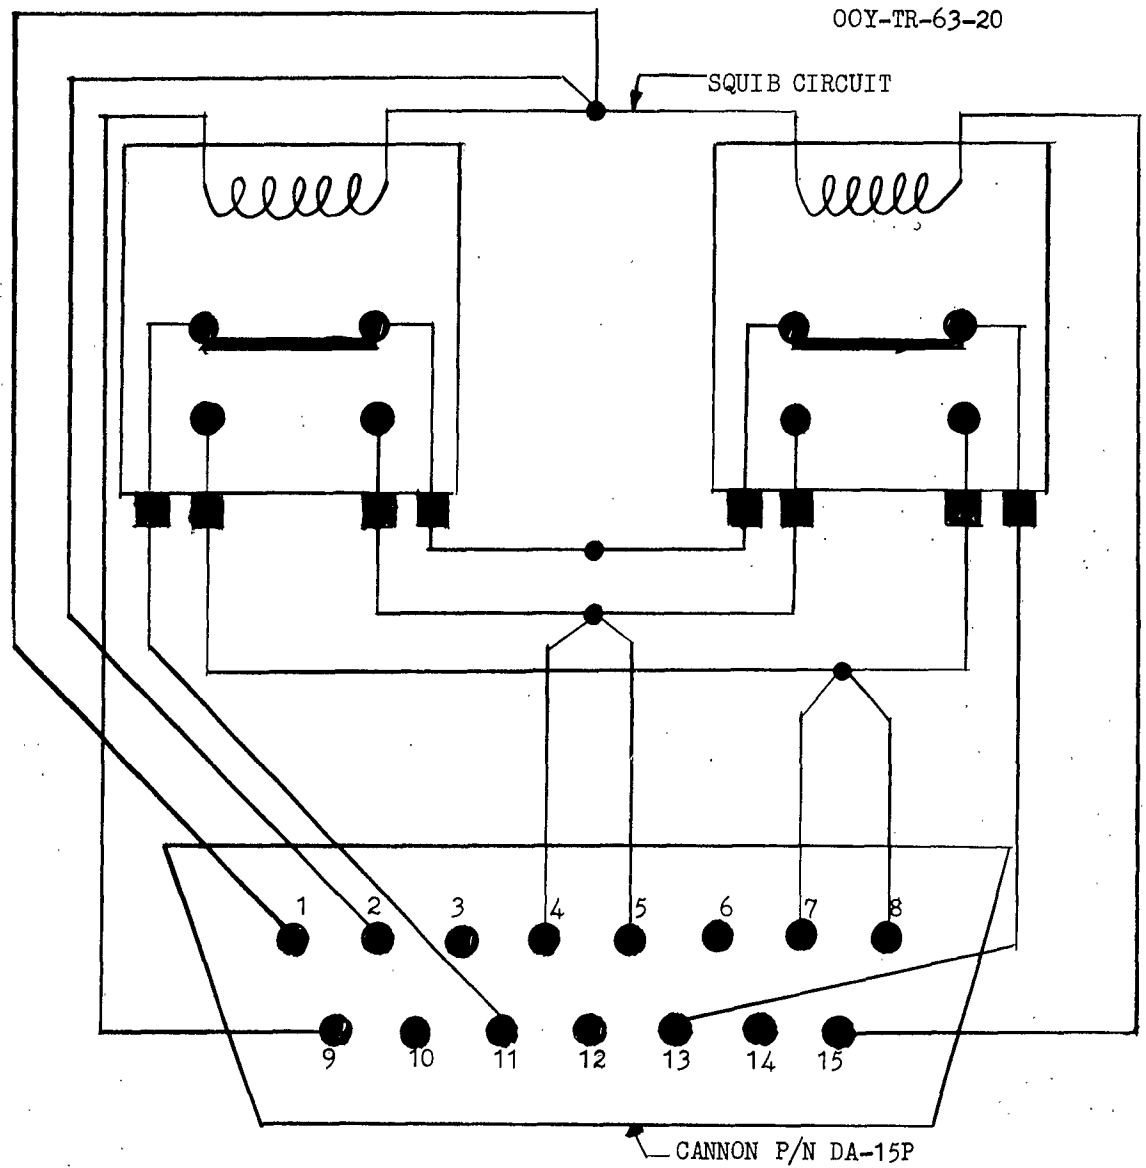
FIGURE 2. Internal Electrical Schematic of Switch Module

All switches modules were radiographed to verify that both switches inside the module functioned. This could not be determined electrically because of the parallel hook-up of the two normally open contacts and the series hook-up of the normally closed contacts inside the module (Figure 2).
